# **Whitehorse**

## **Vehicle Emissions Testing Clinic**

**June 4<sup>th</sup> and 5<sup>th</sup> 2009**

### **Final Report**

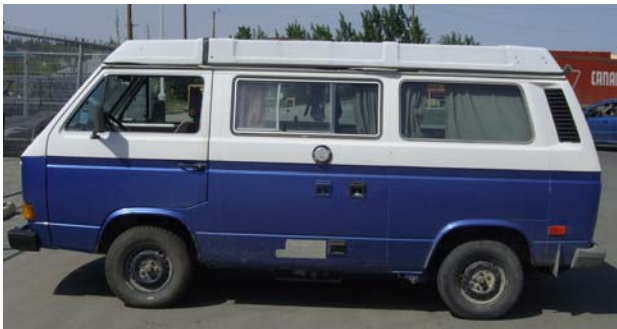
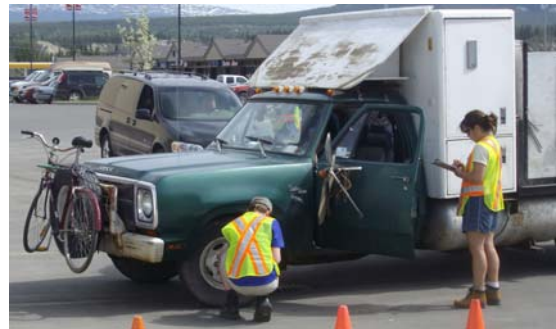
The other two vehicles that stood out as particularly high emitters were a 1984 Volkswagen Vanagon and a 1980 Dodge truck running on propane. The VW Vanagon had very high CO and HC readings at the tailpipe. It also had a gross exhaust leak just upstream of the catalytic converter that caused the readings to be greatly diluted (as indicated by very high O2 concentrations), so the actual HC and CO concentrations from the engine would have been 2 or 3 times what was measured at the tailpipe. Fortunately this vehicle is not usually driven. Even so, considering that its emissions are likely 100 times the level expected from a new car or truck, even driving it 200 km a year will produce the same HC and CO emissions as 20,000km in a 2009 model year vehicle.

The owner of the propane Dodge truck claimed to have converted to propane 'for the environment'. The truck's emission controls were all disabled or removed, although this might have happened before the conversion. It was once common to remove emission components as part of propane conversions, but this was in the entirely incorrect belief that they were no longer needed when running on propane. In the Vancouver area, all such conversions very quickly failed their emission inspections as soon as the AirCare Program started in 1992, and now there are very few propane vehicles still operating in the region. This particular truck had extremely high HC emissions (unburned fuel in the exhaust) - more than twice as high as any other vehicle tested, as well as very high CO.

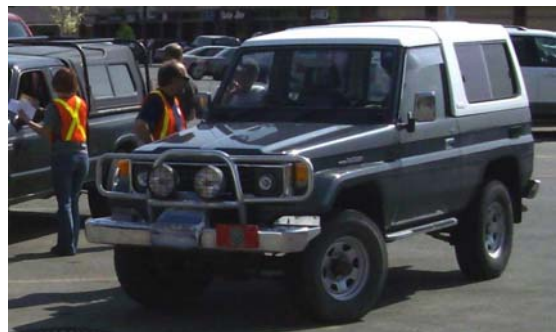
The Japanese Landcruiser on 50% biodiesel was tested as though it was a gasoline vehicle. It measured 35

mg/m<sup>3</sup> at curb-idle and 13 mg/m<sup>3</sup> at high-idle. This confirmed that, although all the other emission indicators (smoke opacity and HC and CO concentrations) were very good, a diesel engine always emits much more PM than gasoline engines. The inherent characteristics of diesel fuel and the direct injection of diesel fuel into the cylinder means that carbon particles will always be formed. Diesel engine technologies such as common rail injection use extremely high injection pressures (25,000 psi or more) to create finer atomization of the fuel droplets but the burning of these small droplets as opposed to vaporized gasoline will always produce more particulate matter. Only the newest diesel engines (2007 and later) have diesel particulate filters (DPF) that trap the particles and prevent their escape out the tailpipe. There were four such vehicles tested; they were a 2007 Dodge Ram 3500, a 2007 GMC 2500, and two 2008 GMC 2500s. Their results confirmed the effectiveness of the DPFs, as all four had no measurable output of PM<sub>10</sub> on any of the snap accelerations performed, and all had 0% opacity readings. Another similar Dodge Ram 3500 with a 2006-spec engine of the same type but with a diesel oxidation catalyst instead of a DPF, recorded PM<sub>10</sub> readings of about 130 mg/m<sup>3</sup> and average smoke opacity of 7%.
